Improvement in Sleeper Casting Process – A Case Study from Ghana

This project involves construction of Single Standard Gauge Railway line from Tema to Akosombo on EPC Basis in Ghana, West Africa. One of the major scopes of work is casting of railway sleepers. The quantity of sleeper to be cast for the construction of rail track is approx. 200,000 in numbers. Thus, production of the sleeper was on a critical path, to complete the project within the scheduled time. During the initial production period, it was observed that performance of the sleeper plant was not effective. The rejection rate was as high as 3.18% of the days production. This high rate of rejection will have an impact on the cost as well as completion time of project leading to performance of the organisation in the region. This paper describes how the project team was able to effectively identify and eliminate the possible reasons for rejection of railway sleepers using the root cause analysis. This has not only improved the quality of the product but also demonstrated the capability of the team to handle the big projects effectively. Collaborative efforts were carried out along with the supplier to eliminate possib

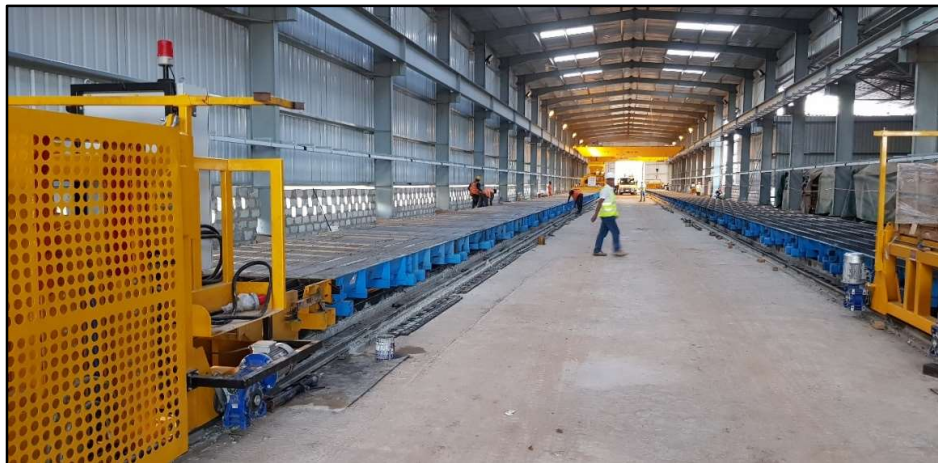
Figure 1: Inside View of Sleeper Production Plant

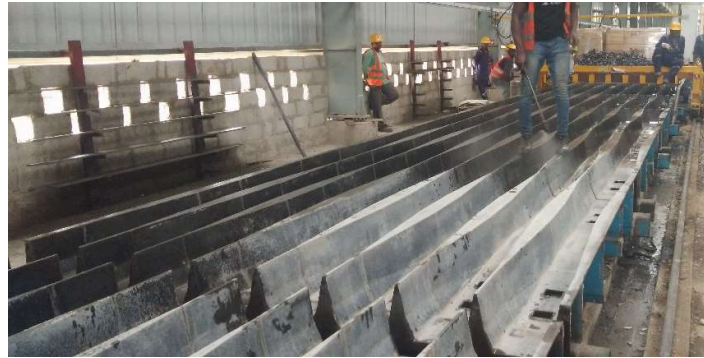
The production of sleepers is done systematically by following the standard method of production to meet the specification. [2] The first step is preparation of moulds for casting by proper cleaning and greasing. The cast-in fastening components are placed in the mould as shown in Figure 2.

Figure 2: Cleaning and Greasing of Mould

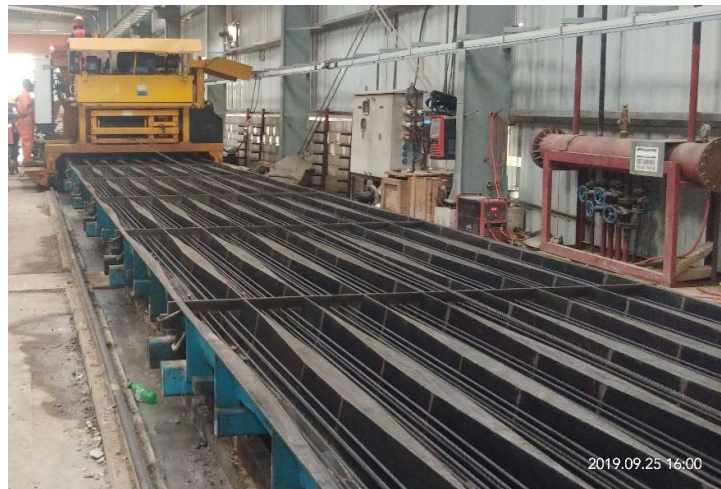
Then 8x8 numbers of High-Tension-Strands (HTS) wires are placed in a predetermined position in each line. They are then pre-tensioned by a hydraulic jack to give a certain initial pre-stress force as shown in Figure.

Figure 3: Placing of HTS Wires in Position for Stressing

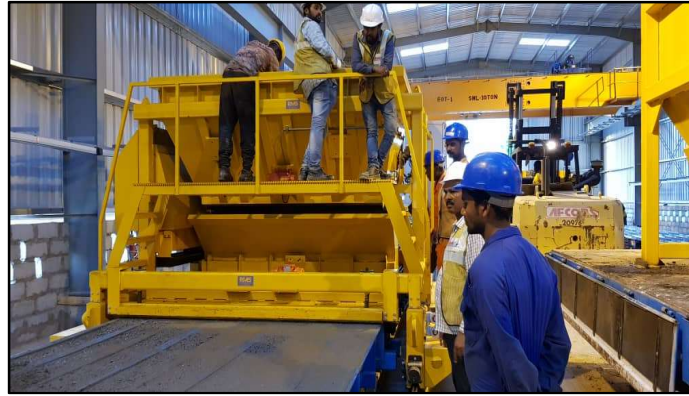
Casting of sleepers using a mechanical casting machine [3] as shown in **Error! Reference source not found.**, which is a continuous process till completion of concrete for the entire casting line. The casting process generally take 3 to 4 hours to complete one line.

Figure 4: Concreting of Sleepers with Mechanical Casting Machine

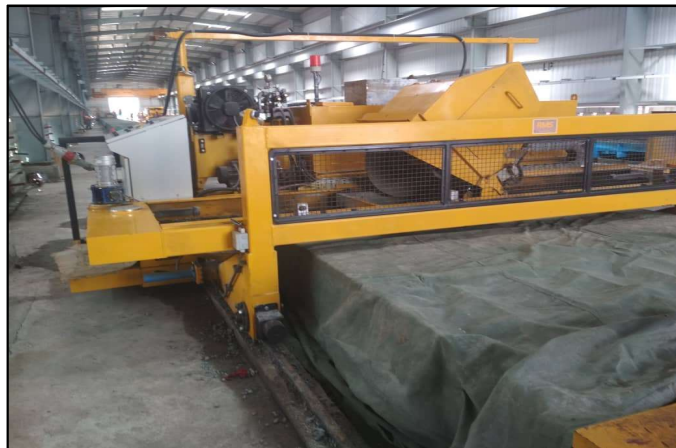
The concreted line has been covered with Tarpaulin and waited till completion of initial setting time of two hours. Once the Initial Setting time is completed, Steam Curing process initiated as shown in Figure and continued for 10 to 12 hours until the required strength of concrete achieved. When the temperature starts to decrease and the compressive strength of 40 MPa is achieved, the sleepers are safe to release of the pre-stressing force.

Figure 5: Steam Curing for Concrete Sleepers

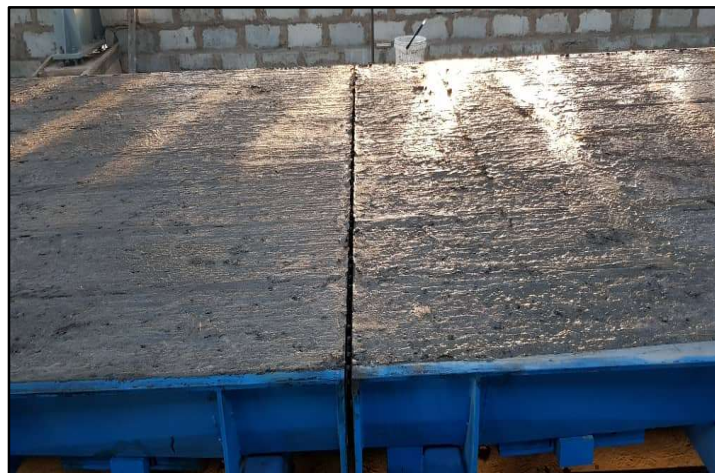
Once the steam curing time is completed, the stress released for HT Strands by cutting as shown in Figure . Sleepers are then de-moulded by demoulding and cutting machine which they are cut to exact length with a diamond saw.

Figure 6: Cutting of HTS Wires to Destress the Sleepers

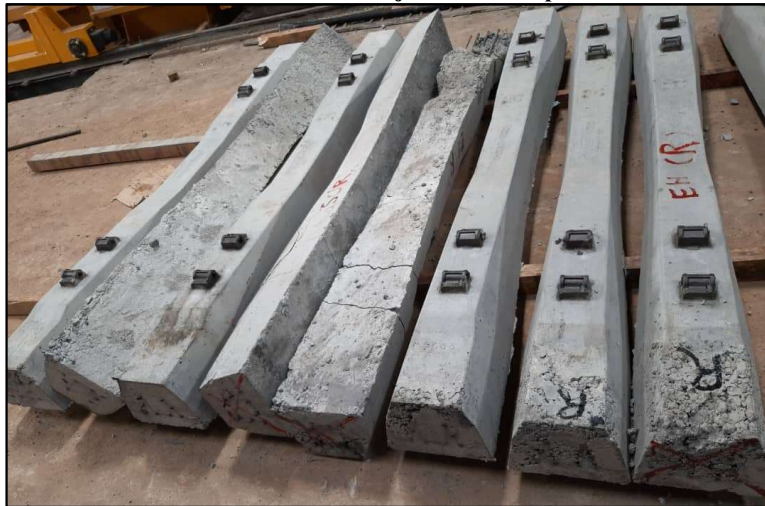
During de-stressing two issues observed in the final product one is breaking and second is honeycomb in sleepers as shown in Figure . The initial rejection of sleepers was approximately 3.18% as shown in Table 1 which indicates the need to eliminate the rejection from the process to improve the productivity.

Figure 7: Breaking and Honeycomb in Sleeper

The releasing stroke to be given by the stressing jacks was calculated as per the elongation of the standard un-embedded wire of the bed & then checked the Anchorage bond between the Concrete & embedded HTS wires after de-stressing.[7] It was observed that there is slippage in the HTS wires which is embedded inside the concrete. As the extra-elongation of wire was not considered in the releasing stroke of the de-stressing jack additional stress developed in the strand. This additional stress in the HTS wire causing thrust on the face of the

sleeper resulted in edge breaking. Thus, excess slippage of HTS wire needs to be controlled in order to safeguard the breaking of edges in the sleeper. Hence it was necessary to understand the main cause of slippage of HTS strand in the sleeper. Further it was concluded by conducting brain storming session that the possible reasons of slippage of HTS strand could be

Finally, improved process was tried by submerging the HTS strand coil in the lime solution and then application of jet spray for cleaning the strand. This process has improved the performance of the HTS wire in the sleepers significantly. It was observed that the slippage was within permissible limits during the process of destressing for sleepers. This resulted in improving the sleeper quality by eliminating defects like broken edges or crack development of sleeper during destressing. Finally, non-grease coated HTS wires were also tried in the sleeper production from alternate source instead of grease coated HTS wire. It was observed that no crack and slippages of HTS wire in the Sleeper is evident.

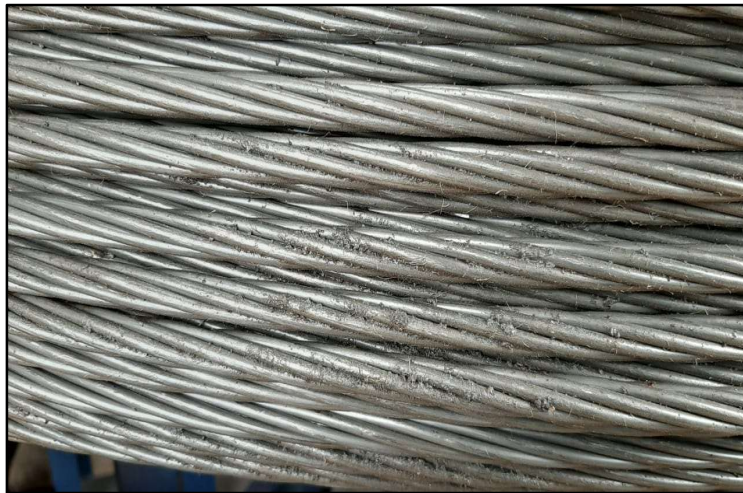
Based on visual inspections HTS wires were coated with grease to keep the material corrosion free during transportation. The application of grease was in excess, contributing the poor development of bond strength between the wire and the concrete. Trials were done using the cleaned wire to produce sleeper.

Initially, measures have taken to remove the excessive grease manually using Jute & cotton cloths. It is observed that the slippage of embedded strands is not within the permissible limits. The traces of grease were evident in the strand as shown in Figure . As an improvement the cleaning of deposited grease in the HTS wires was tried by application of jet spray using normal water. It was observed that grease deposited inside the core is not being removed in this process. Therefore, during destressing the slippage of HTS wires again recorded beyond the specified limit.

Figure 8: Excess Grease Application on HTS Wire

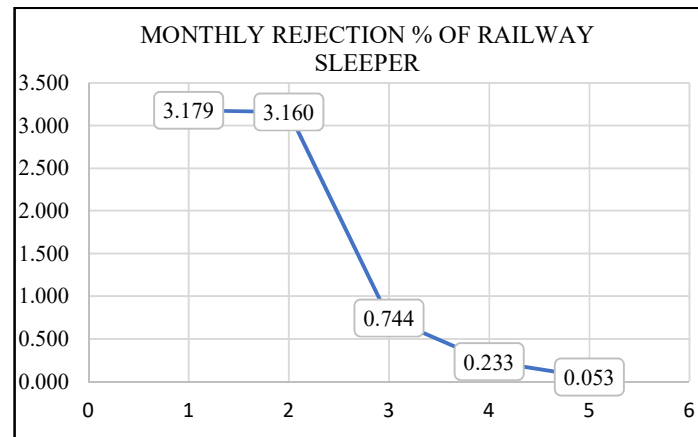
The improvement in the quality of sleepers produced during the subsequent months showed the effectiveness of the root cause analysis done by the project team. The rate of rejection was constantly reduced starting from the month of May'2019 till August'2019 from 3.16% to 0.053% with overall rejection till date being 0.89% as

shown in 9. The change in process of using the existing HTS wire and ordering the new with no coating on the strands helped the project to control the rejection of sleeper during production. The Root Cause Analysis for defects such as edge breaking in sleepers is captured using '5 whys' technique in a flow diagram as shown in 10. Corrective action implemented in the production of sleeper and reduced the reject rate to 0.053% by the end of August'2019.

Figure 9: Monthly Rejection Rate for Sleepers Starting April'2019
